DOUGLAS AIRCRAFT COMPANY

Section	n			<u>Page</u>
1.0	INTE	RODUCTIO	N	. 1
2.0	FACILITY BACKGROUND			
	2.1	FACILIT	Y DESCRIPTION	. 1
	2.2	REGULA	ATORY STATUS	. 2
	2.3	HAZARI	DOUS WASTE ACTIVITY	. 2
3.0	INSP	ECTION OF	BSERVATIONS	. 4
	3.1	FIELD IN	NSPECTION	. 4
		3.1.1 3.1.2 3.1.3	Buildings 3, 4, 5, and 6 Building 47 Buildings 85 and 87	. 7
	3.2 DOCUMENT REVIEW			12
		3.2.1 3.2.2 3.2.3	Biennial Reports	12 12 12
	3.3 STATUS OF PREVIOUS VIOLATIONS			13
	3.4	DISCUSS	ION WITH FACILITY MANAGEMENT	13
4.0	POTENTIAL VIOLATIONS		14	
Appen	dix			
Α	CEI CHECKLIST			
В	NOTIFICATION OF HAZARDOUS WASTE ACTIVITY FORM			
С	INSPECTION PHOTOGRAPHS			
D	FLUORESCENT PENETRANT MSDS			
E	TANK INSTALLATION REPORT

Following a review of facility information, PRC performed a CEI on August 21, 1990, at Douglas Aircraft Company (Douglas Aircraft), located in Long Beach, California. The CEI consisted of a facility walk-through and a review of applicable hazardous waste management documents. The CEI evaluated the facility's compliance with applicable Federal regulations specified in 40 CFR Parts 260 through 270, which regulate generators of hazardous waste. The evaluation included completing a checklist develope

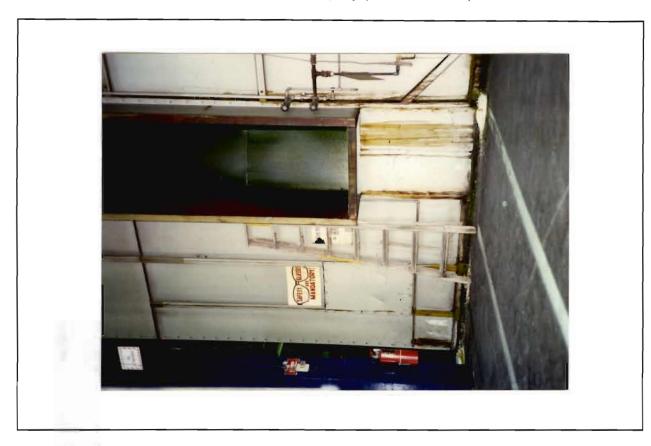
Photograph No. 1 Date: 8/21/90 Photographer: BMS

Inspectors noted leaking around the spray booth and the use of absorbent in some areas to contain this leakage (Appendix C, Photograph 1). Inspectors requested and received a Material Safety Data Sheet (MSDS) for the fluorescent penetrant (Appendix D). Facility representatives stated that, based on the MSDS and by knowledge of process, the used penetrant is not a RCRA-regulated hazardous waste.

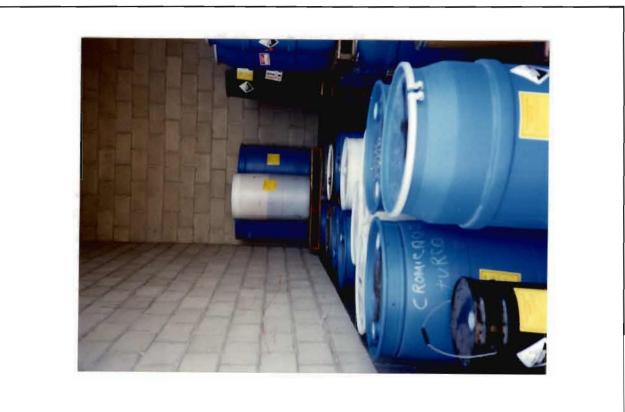
Approximately 40, 55-gallon drums of acidic wastes were in the second bay during the inspection. These drums were primarily poly drums, stored on pallets, and stacked two-high in some areas. This bay appeared to be near full-capacity. The drums were all labeled and consisted primarily of corrosive liquid and solid wastes (salts) classified as D002 and D007 wastes. All drums inspected were in good condition, and inspectors did not note any leakage on the floor of the bay. However, there was inadequate aisle space and inspectors could not access drums along the sides of the bay (Appendix C, Photographs 2 and 3).

- One unlabeled drum of desmut in the accumulation area did not have an accumulation date marked on it. [40 CFR Part 262.34(a)(2)]
- There was inadequate aisle space in the bay containing acidic wastes in the accumulation area at Building 47 (Appendix C, Photographs 2 and 3). [40 CFR Part 262.34(a)(4) directing to 40 CFR Part 265.35]

Photograph No. 2 Date: 8/21/90 Photographer: BMS Subject: Acidic Wastes Bay in the Accumulation Area (Note Inadequate Aisle Space)

The personnel who work in the hazardous waste accumulation yard have been instructed to maintain adequate aisle space throughout building 47. In order to help insure that adequate aisle space is maintained at all times, an item has been added to the daily inspection checklist which requires that personnel in the waste accumulation yard check for adequate aisle space.

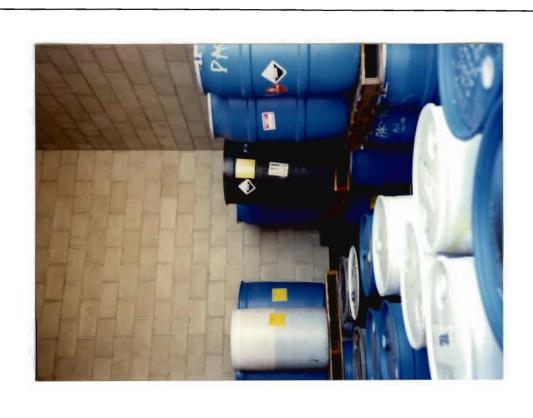
Photograph No. 3 Date: 8/21/90 Photographer: BMS Subject: Acidic Wastes Bay in the Accumulation Area (Note Inadequate Aisle Space)

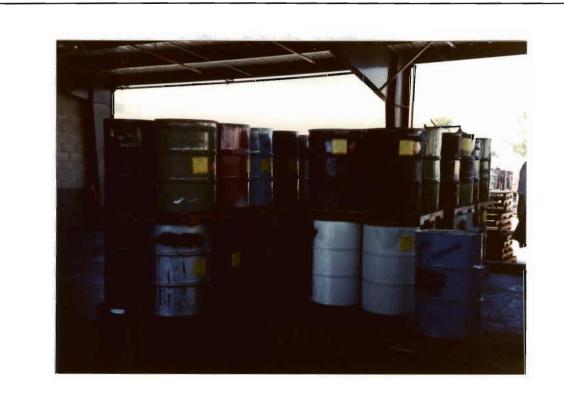
During the inspection, there were over 100, 55-gallon drums of flammable wastes in the third bay, which is several times larger than the other bays (Appendix C, Photograph 4). According to facility representatives, the drummed wastes in this bay (primarily solvent/paint sludges) are consistently produced at the facility and have similar characteristics. However, inspectors noted that these drums were classified inconsistently: some drums were classified as D001/F002/F003/F005 and some were classified as F002/F003/F005. Facility representatives, stated that the D001/F002/F003/F005 classification is most accurate and would be used to consistently classify these wastes in the future.

Photograph No. 4 Date: 8/21/90 Photographer: BMS
Subject: Flammable Wastes Bay in the Accumulation Area

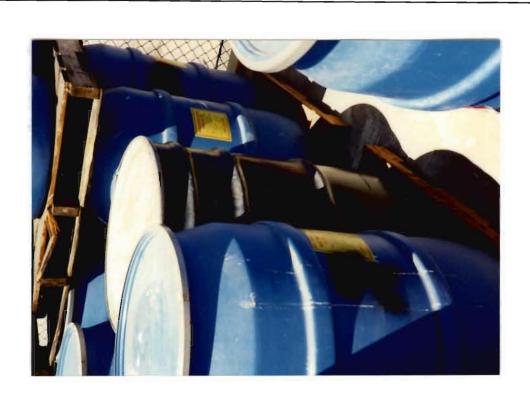
One of the drums of D001/D002 desmut filter cake was unlabelled (see black drum in Appendix C, Photographs 5 and 6). As such, no accumulation date was noted on the drum. However, this drum was marked in paint as "hazardous waste" and "desmut."

Photograph No. 5 Date: 8/21/90 Photographer: BMS Subject: Unlabeled Drum of Desmut Waste in the Accumulation Area

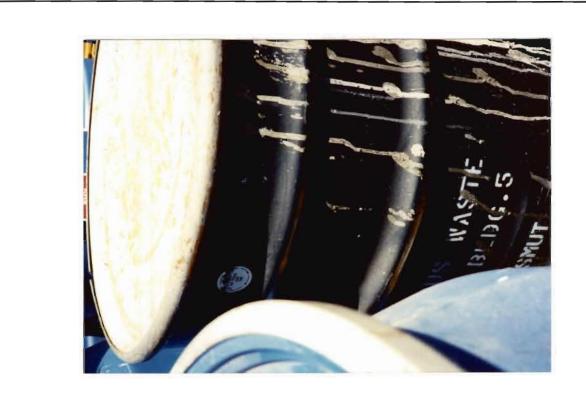
Photograph No. 6 Date: 8/21/90 Photographer: BMS

Subject: Unlabeled Drum of Desmut Waste in the Accumulation Area

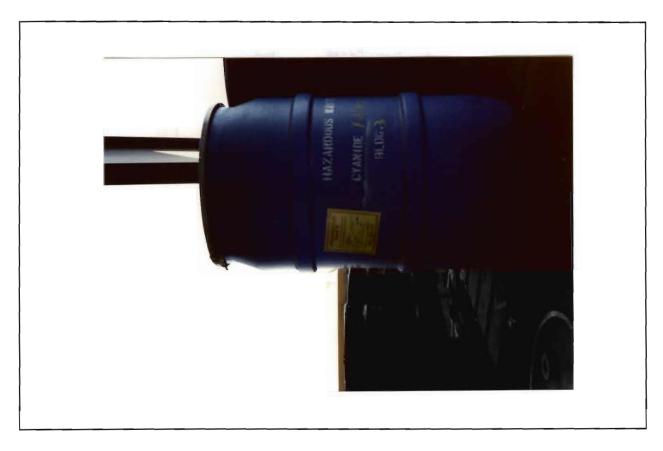
Photograph No. 7 Date: 8/21/90 Photographer: BMS

In addition, inspectors noted one 55-gallon drum that was marked in paint as "hazardous waste - cyanide filters" (Appendix C, Photograph 7). However, the label on the drum indicated the waste was "non-RCRA." Facility representatives stated that the waste was RCRA-regulated and that the label would be corrected.

Subject: Drum of Cyanide Filters Marked as Hazardous Waste
